PRELIMINARY SITE INVESTIGATION

Little Mindil

SLR Ref: 680.30010-R01
Version No: v3.0
September 2019

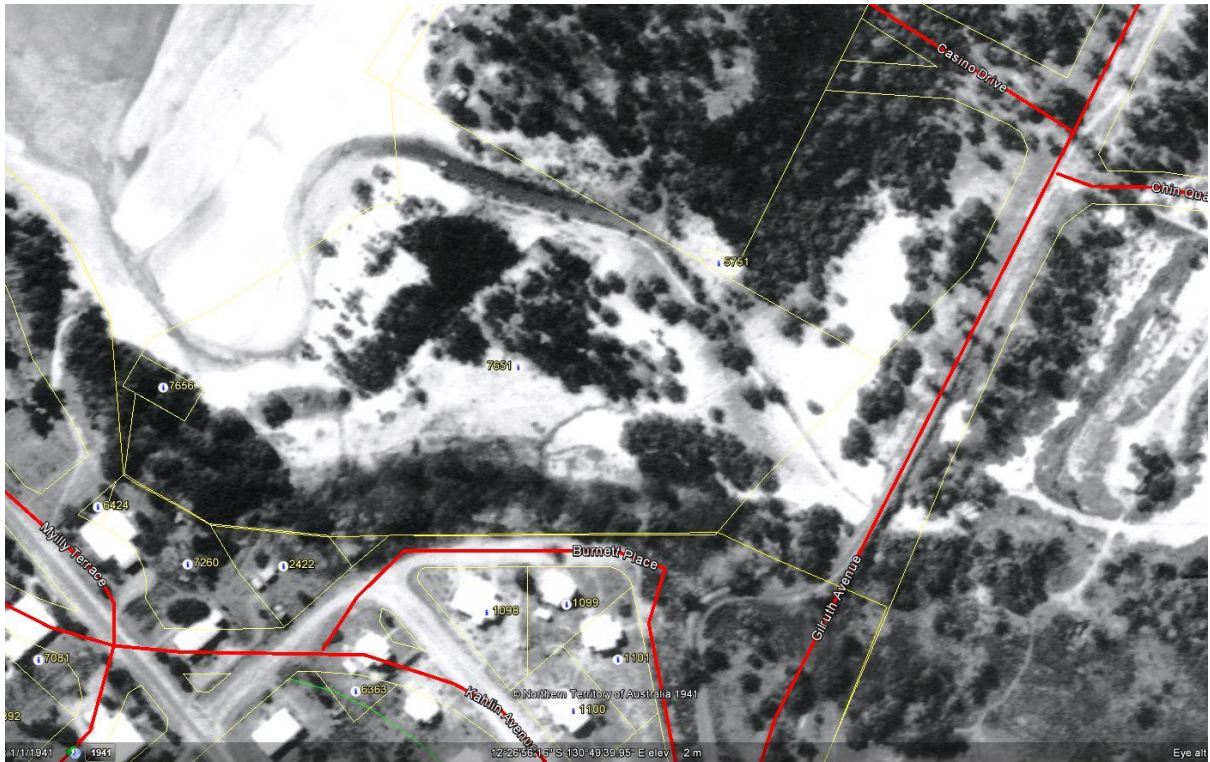
Photo 1 1941

Date	Description
1941	Undeveloped land with apparent woody vegetation. The Casino Lot is also undeveloped in this image. The heritage houses at Myilly Point are observable in this image.
1975	Post Cyclone Tracy, debris from buildings to the west atop the escarpment has been spread across the Site. The electrical substation on to the west of the Site is now in place. Woody vegetation has been cleared and dirt roads transect the Site. Some development including land clearing has occurred across the neighbouring casino Lot.

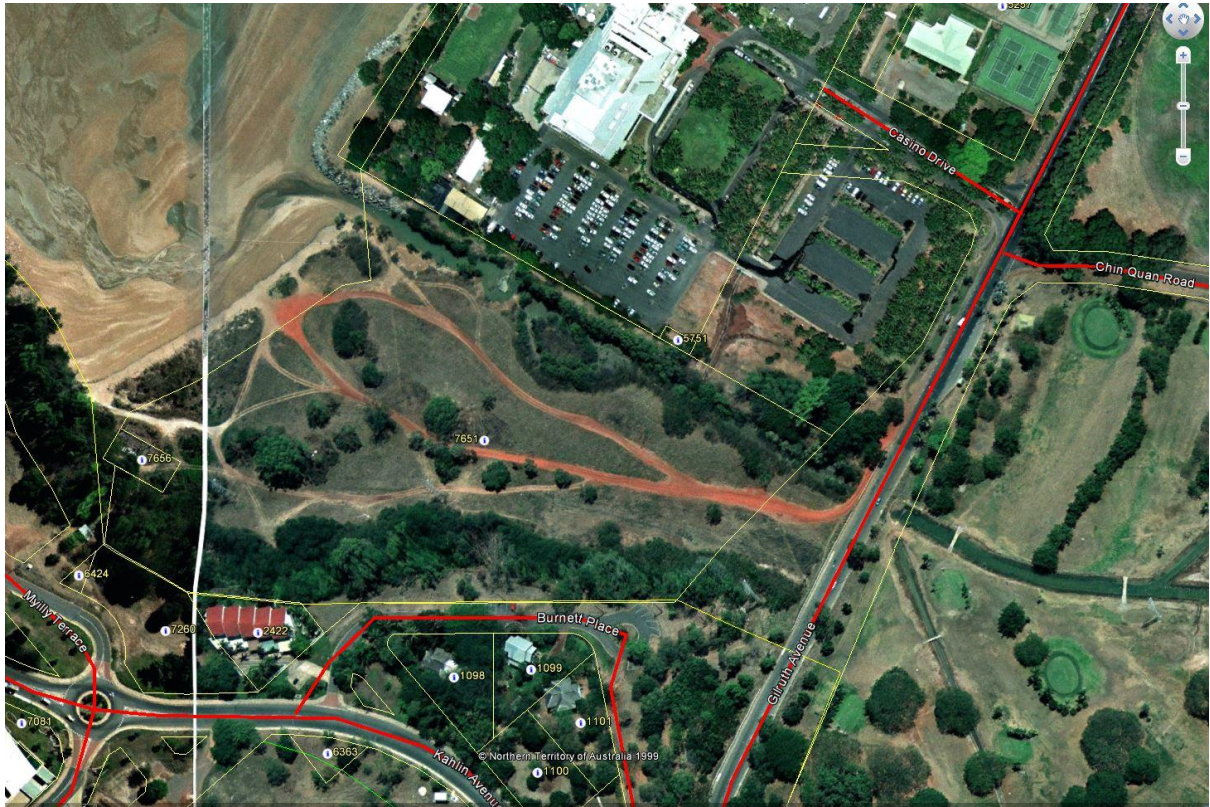
Photo 3 1999

Date	Description
1999	Earthworks have been undertaken along the north-western foreshore portion of the Site and with new access tracks installed. Apparent imported fill material of unknown origin is observable in this picture. The flow of Mindil creek appears to have been altered through these works. The casino and carpark are observable in this image.
2008	The Site appears largely unchanged from previous image. Multi-storey residential buildings have been constructed to the south-west.
2009	The Site appears largely unchanged from previous image.
2010	Installation of footbridges across Mindil creek, the bitumen carpark area and access road from the casino carpark are underway in this image. Significant clearing of vegetation along the southern site boundary has occurred and grass installed on the northern area.
2012 - 2016	The Site appears largely as it does today, with temporary infrastructure relating to events on the Gala lawns observable in some images.

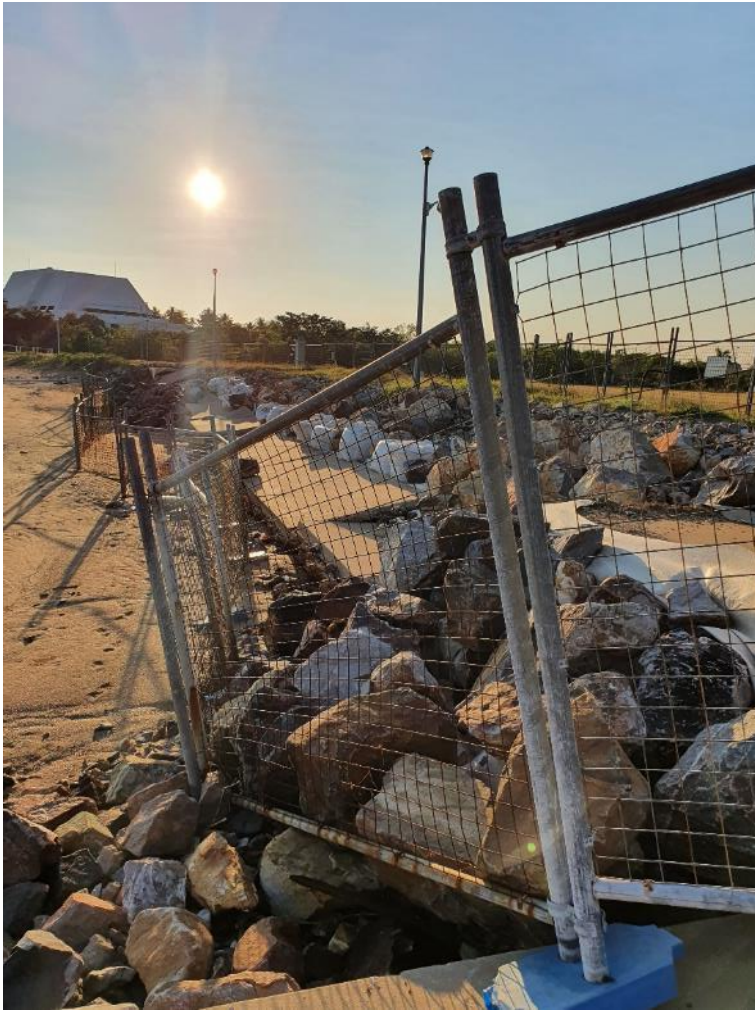
Photo 1 Collapsed walking track adjacent to foreshore

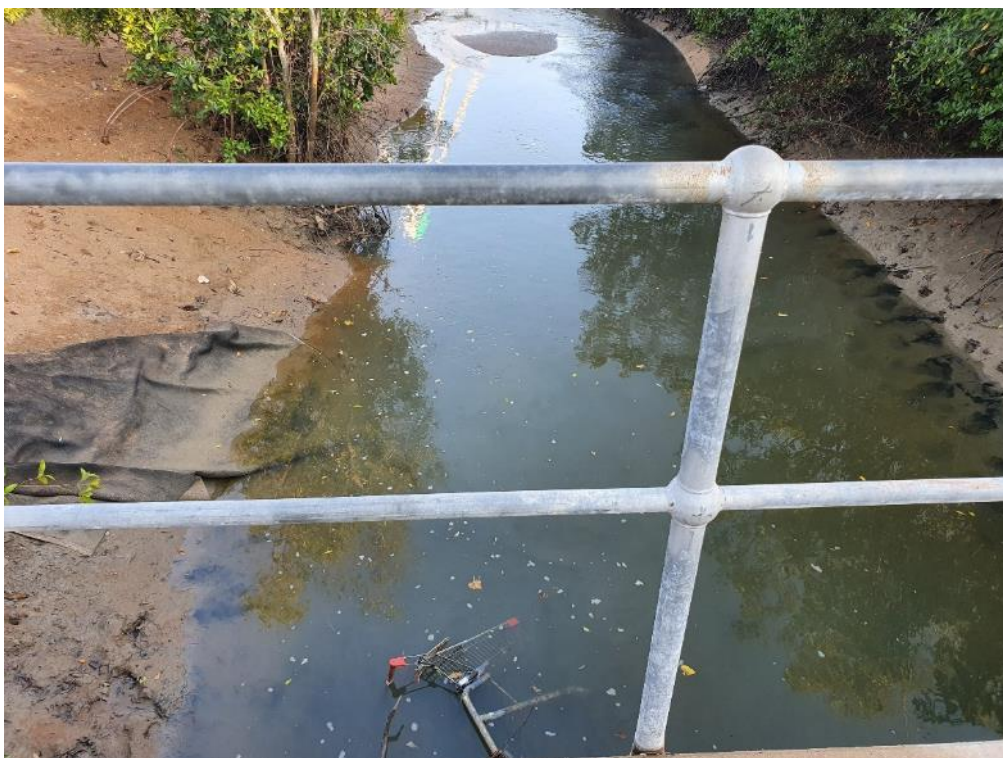
Photo 2 Evidence of dumping in Mindil Creek

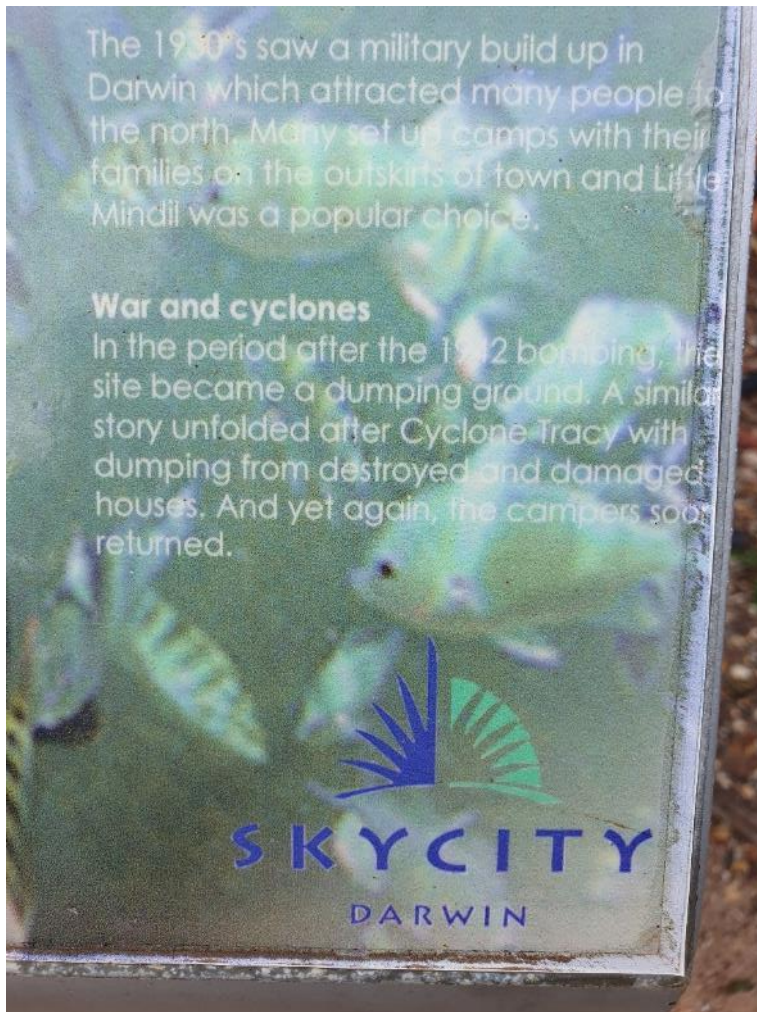
Photo 3 Reference to historic dumping on information signs

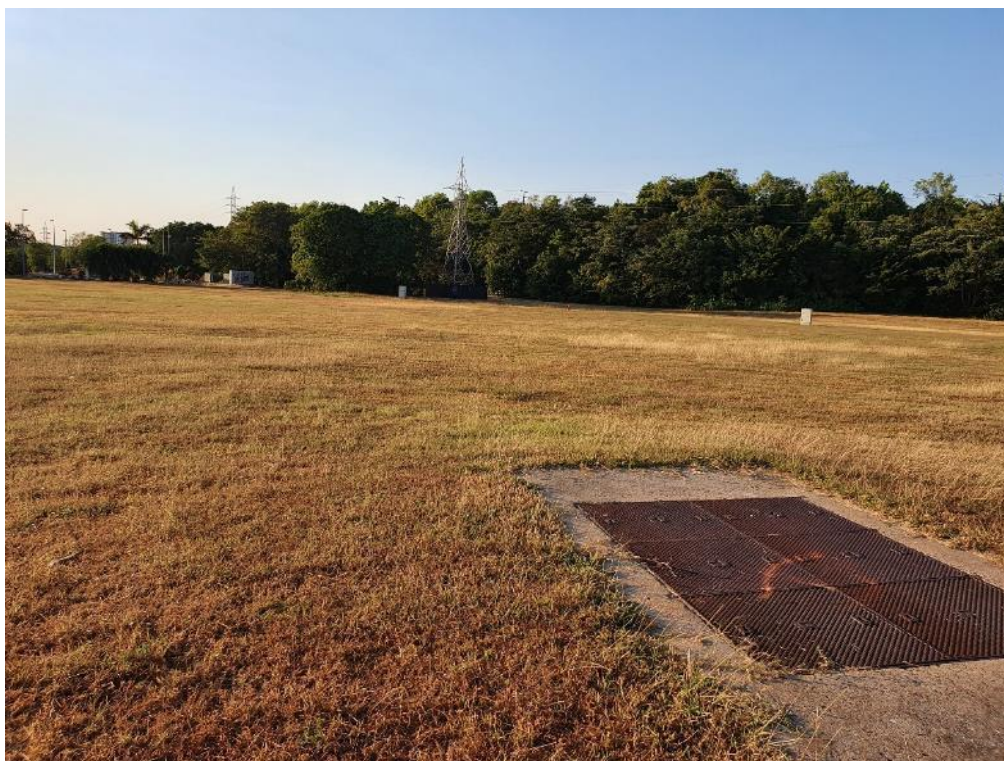
Photo 4 Underground services

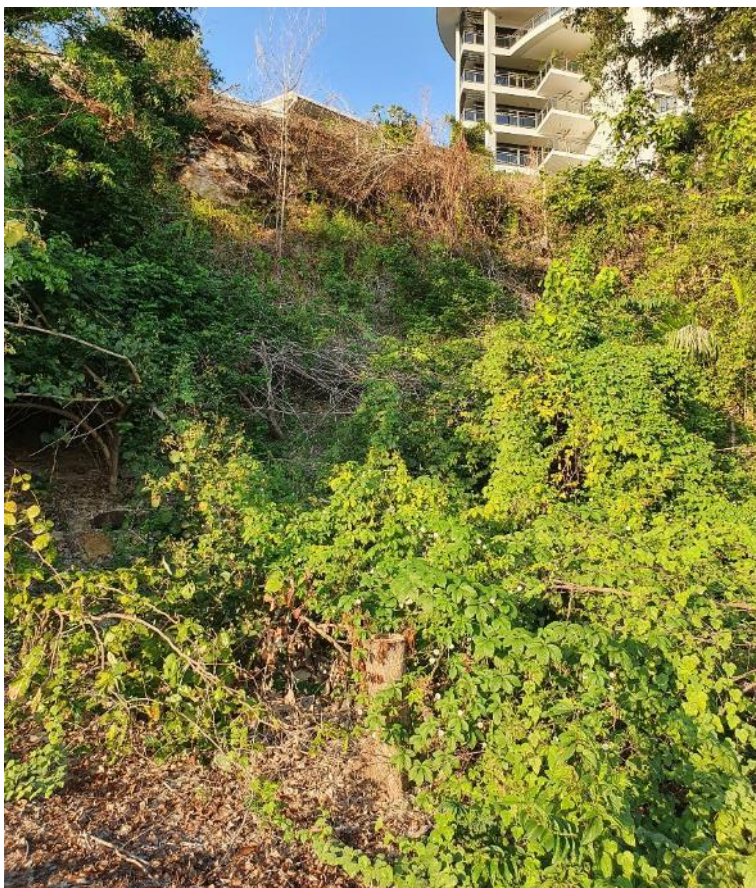
Photo 6 Environmental weeds
