# PRELIMINARY SITE INVESTIGATION

**Little Mindil**

SLR Ref: 680.30010-R01  
Version No: v3.0  
September 2019

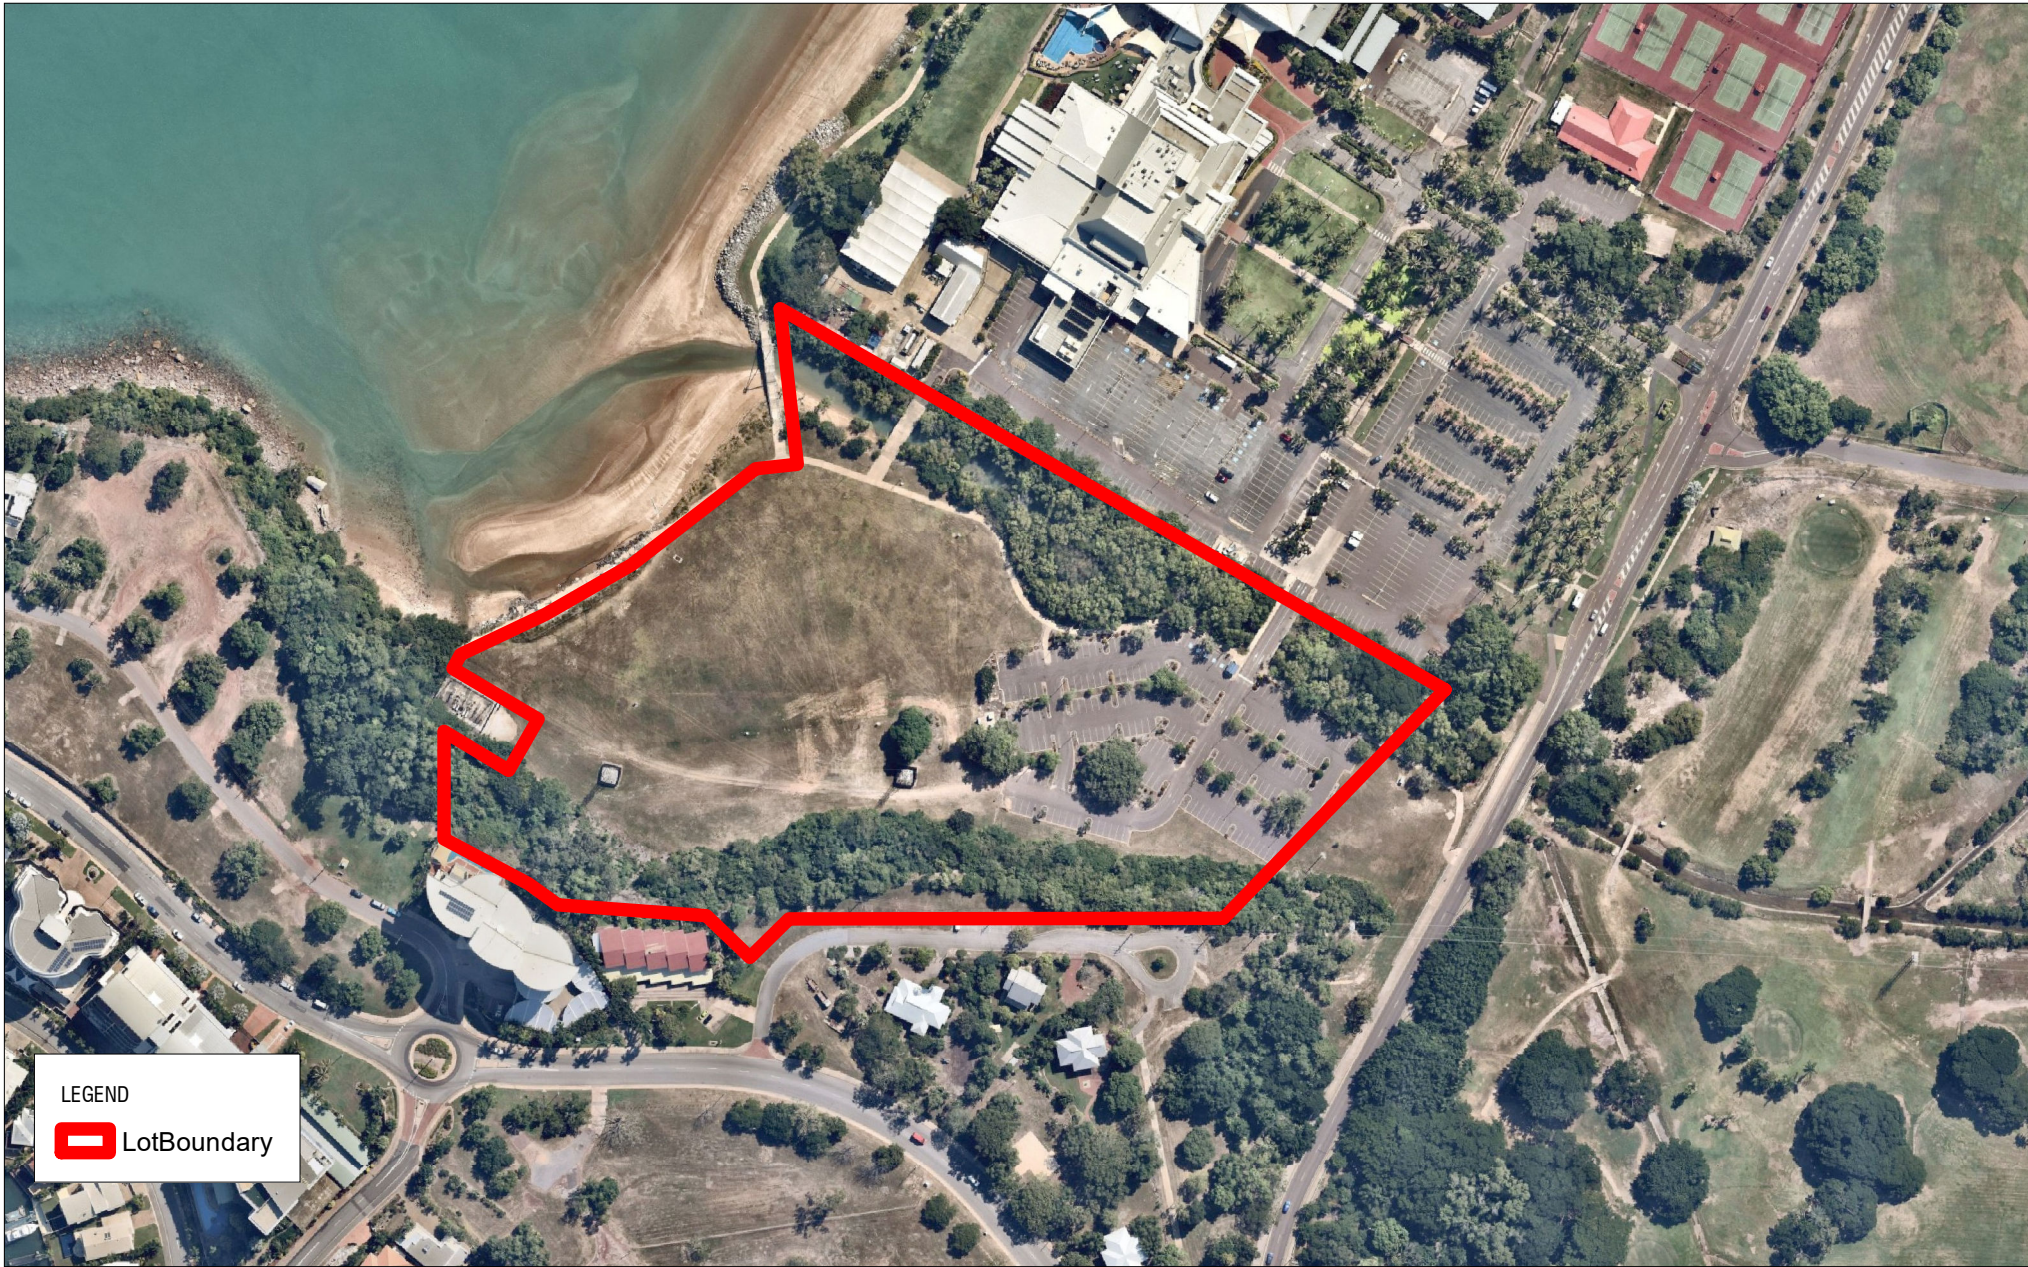
Current Site Aerial  
**Figure 1**

# Site Locality: Lot 7651

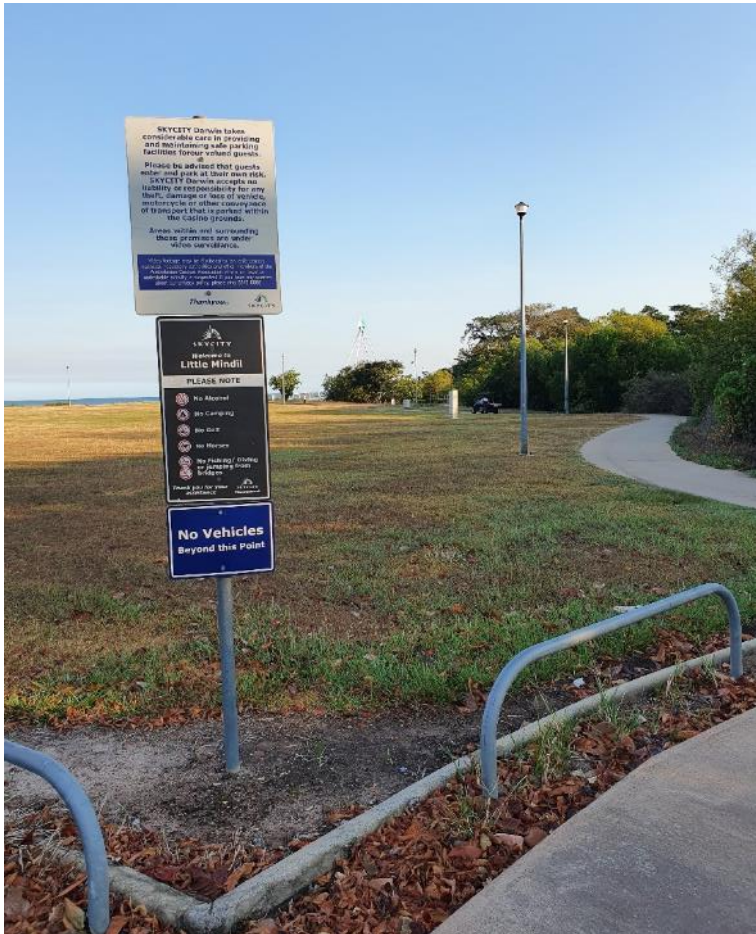
Photo 5 Pedestrian access across site
