# **Farrar West**

## **Engineering Services Plan**

**Project No: 17-182**

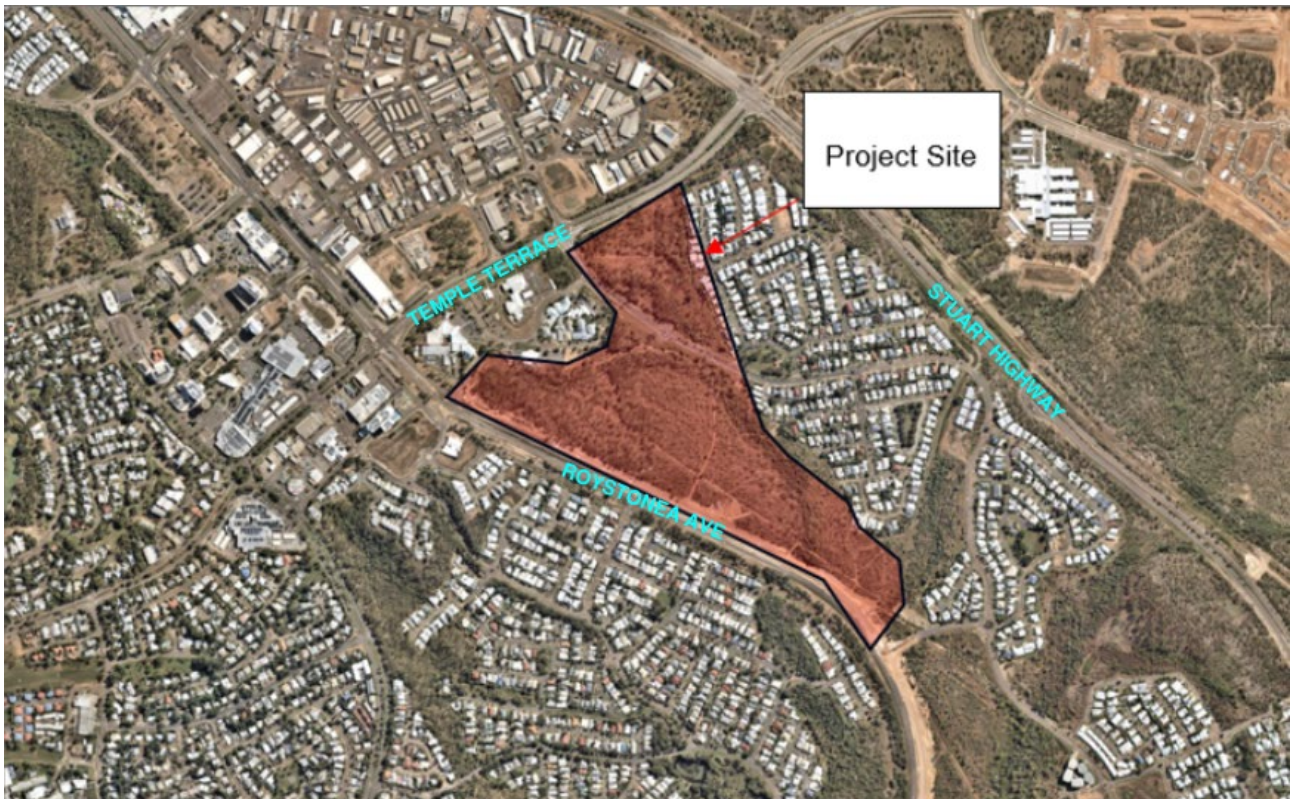
Figure 1: Site Aerial (Nearmap, 2025)

This report summarises the proposed water, sewer and drainage infrastructure planning and design, along with commentary regarding other engineering aspects, such as earthworks, roads and pathways for the proposed Farrar West Development Project, located in Palmerston, Northern Territory as shown in Figure 1 below. The project proposes to subdivide the existing gazetted and undeveloped lots 13256 and 13257 into approximately 250 individual lots, comprised mostly of Low and Low to Medium Density residential housing, in accordance with zoning presented within the Palmerston Eastern Suburbs Planning Principles and Area Plan. Currently gazetted lot 13260 is also included in the masterplan.

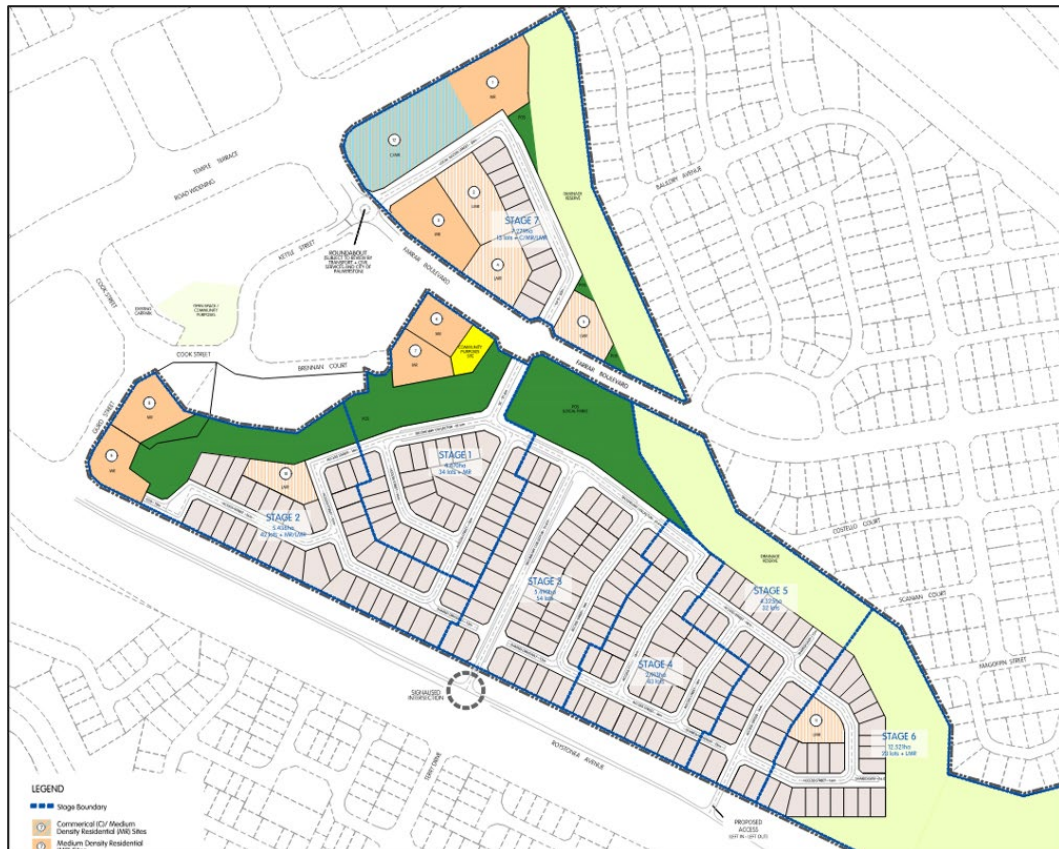
Figure 5: Staging Plan

The project is proposed to be delivered in 7 stages of approximately equal number of allotments, generally progressing from west to east. It is intended that civil infrastructure staging will follow this intent, whereby roads and services would follow the lot boundaries. However, in order to maximise efficiency, and make use of dry season conditions, earthworks are intended to be completed in advanced and for grouped stages over a wider area. As further described below, earthworks are anticipated to be completed in approximately two to three stages in advance of successive subdivision works stages.

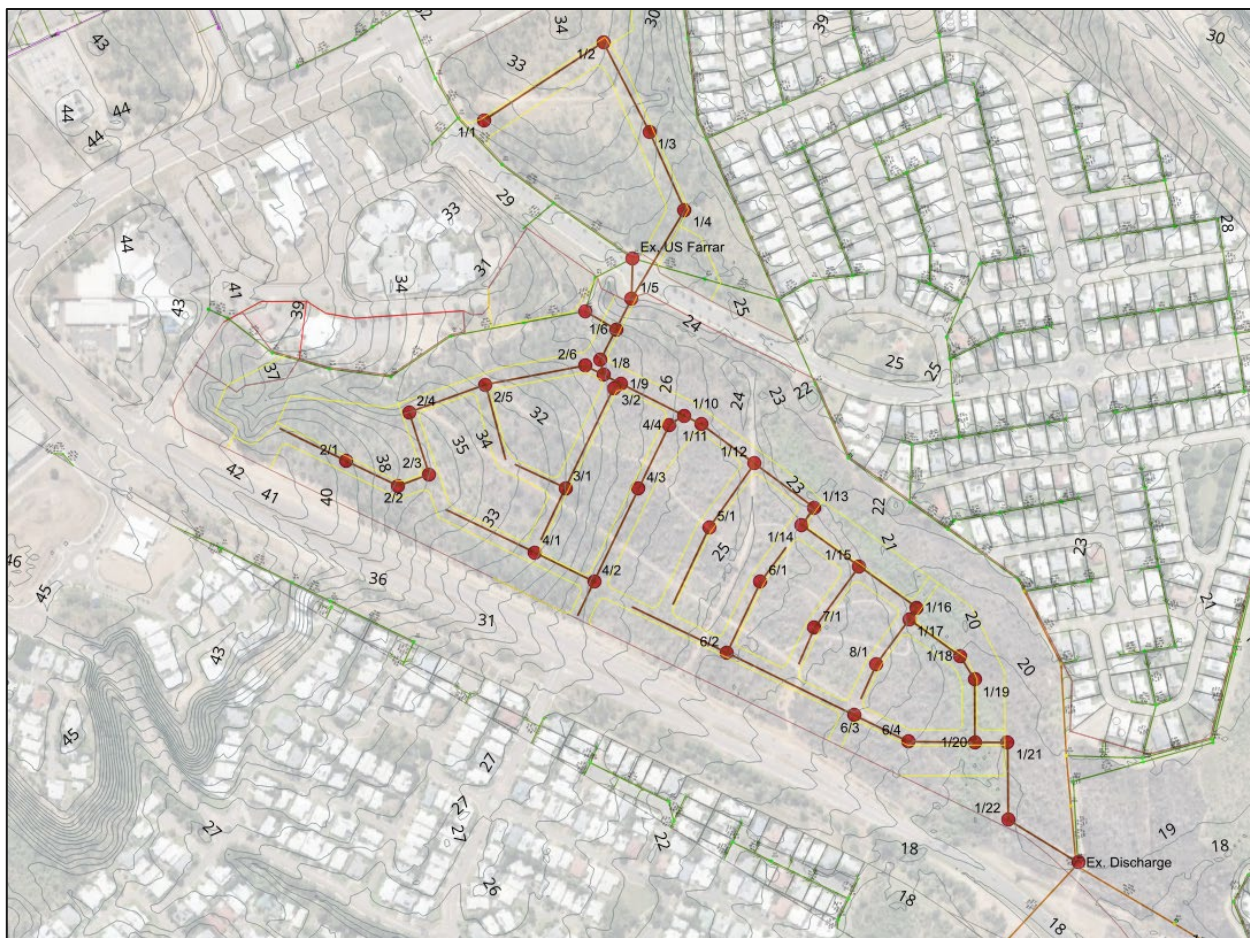
Figure 13: Preliminary Sewer Layout

The existing section of sewer main on the north-eastern side of Farrar Boulevard will be abandoned and rehabilitated on the eastern side of the existing roundabout. All discharge from the development site will converge into the DN600 main on the southern side of Lot 13256. Sewer infrastructure shall be designed and constructed in accordance with Power and Water Corporation standards and requirements.

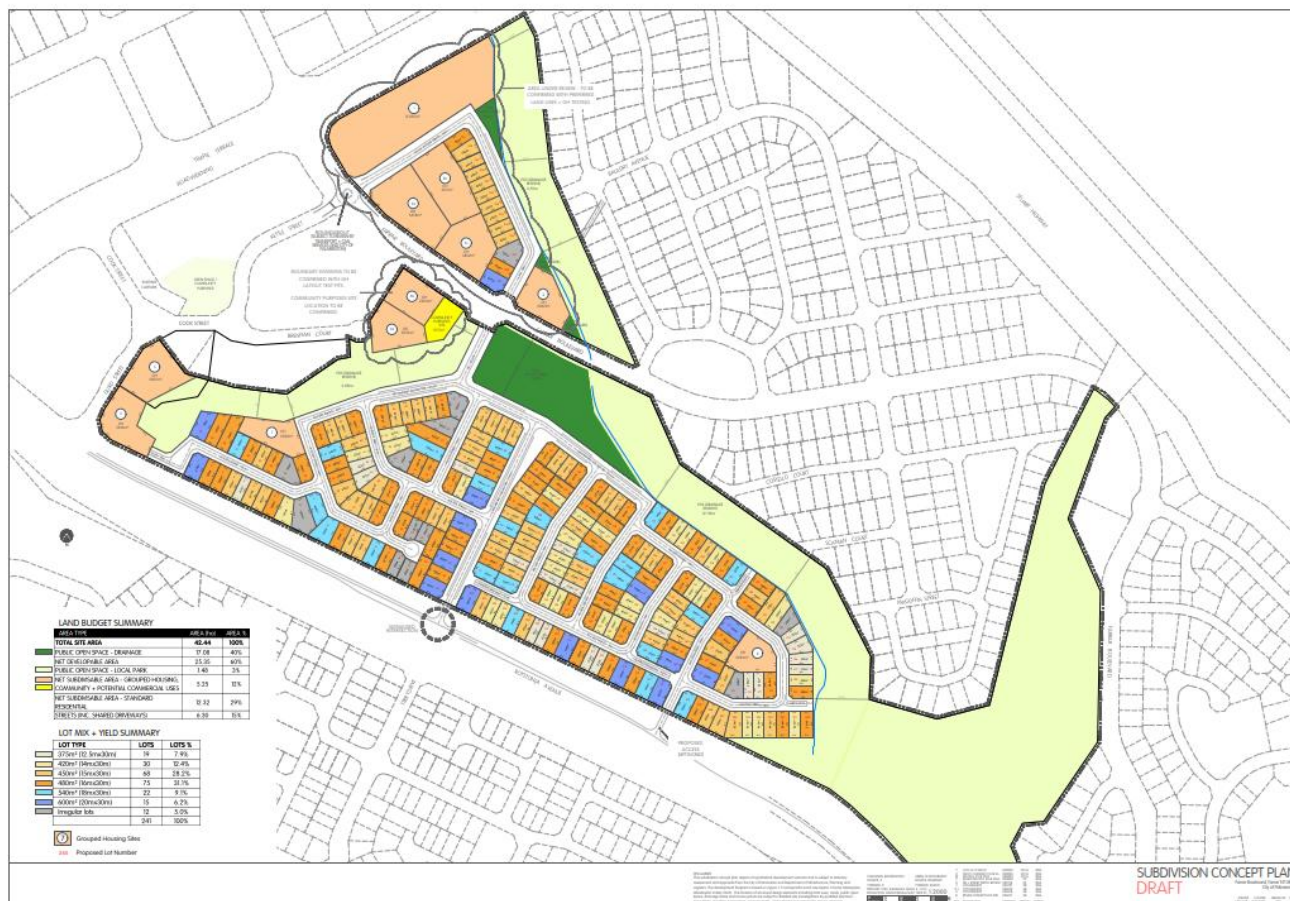
Figure 2: Overview of site condition during investigation

During the time of investigation on 6/07/2026 and 15/07/2026, the overall site was identified to slope downwards toward the east and the southeast, with the highest elevation being 41.0m AHD, and the lowest being ~18.0m AHD. The area appeared to be moderately vegetated with trees reaching heights of approximately 15m, with dense, burned regrowth and savannah. Elevated areas towards the western side of the site seemed to have shorter and dryer grass and more spread-out taller trees, compared to lower lying areas toward the east, which had thicker green grass and the trees were shorter, but closer together.

A number of unsealed tracks were present in the area with evidence of recent vehicle use. **Figure 2** shows the typical site condition that was encountered during the time of visit.

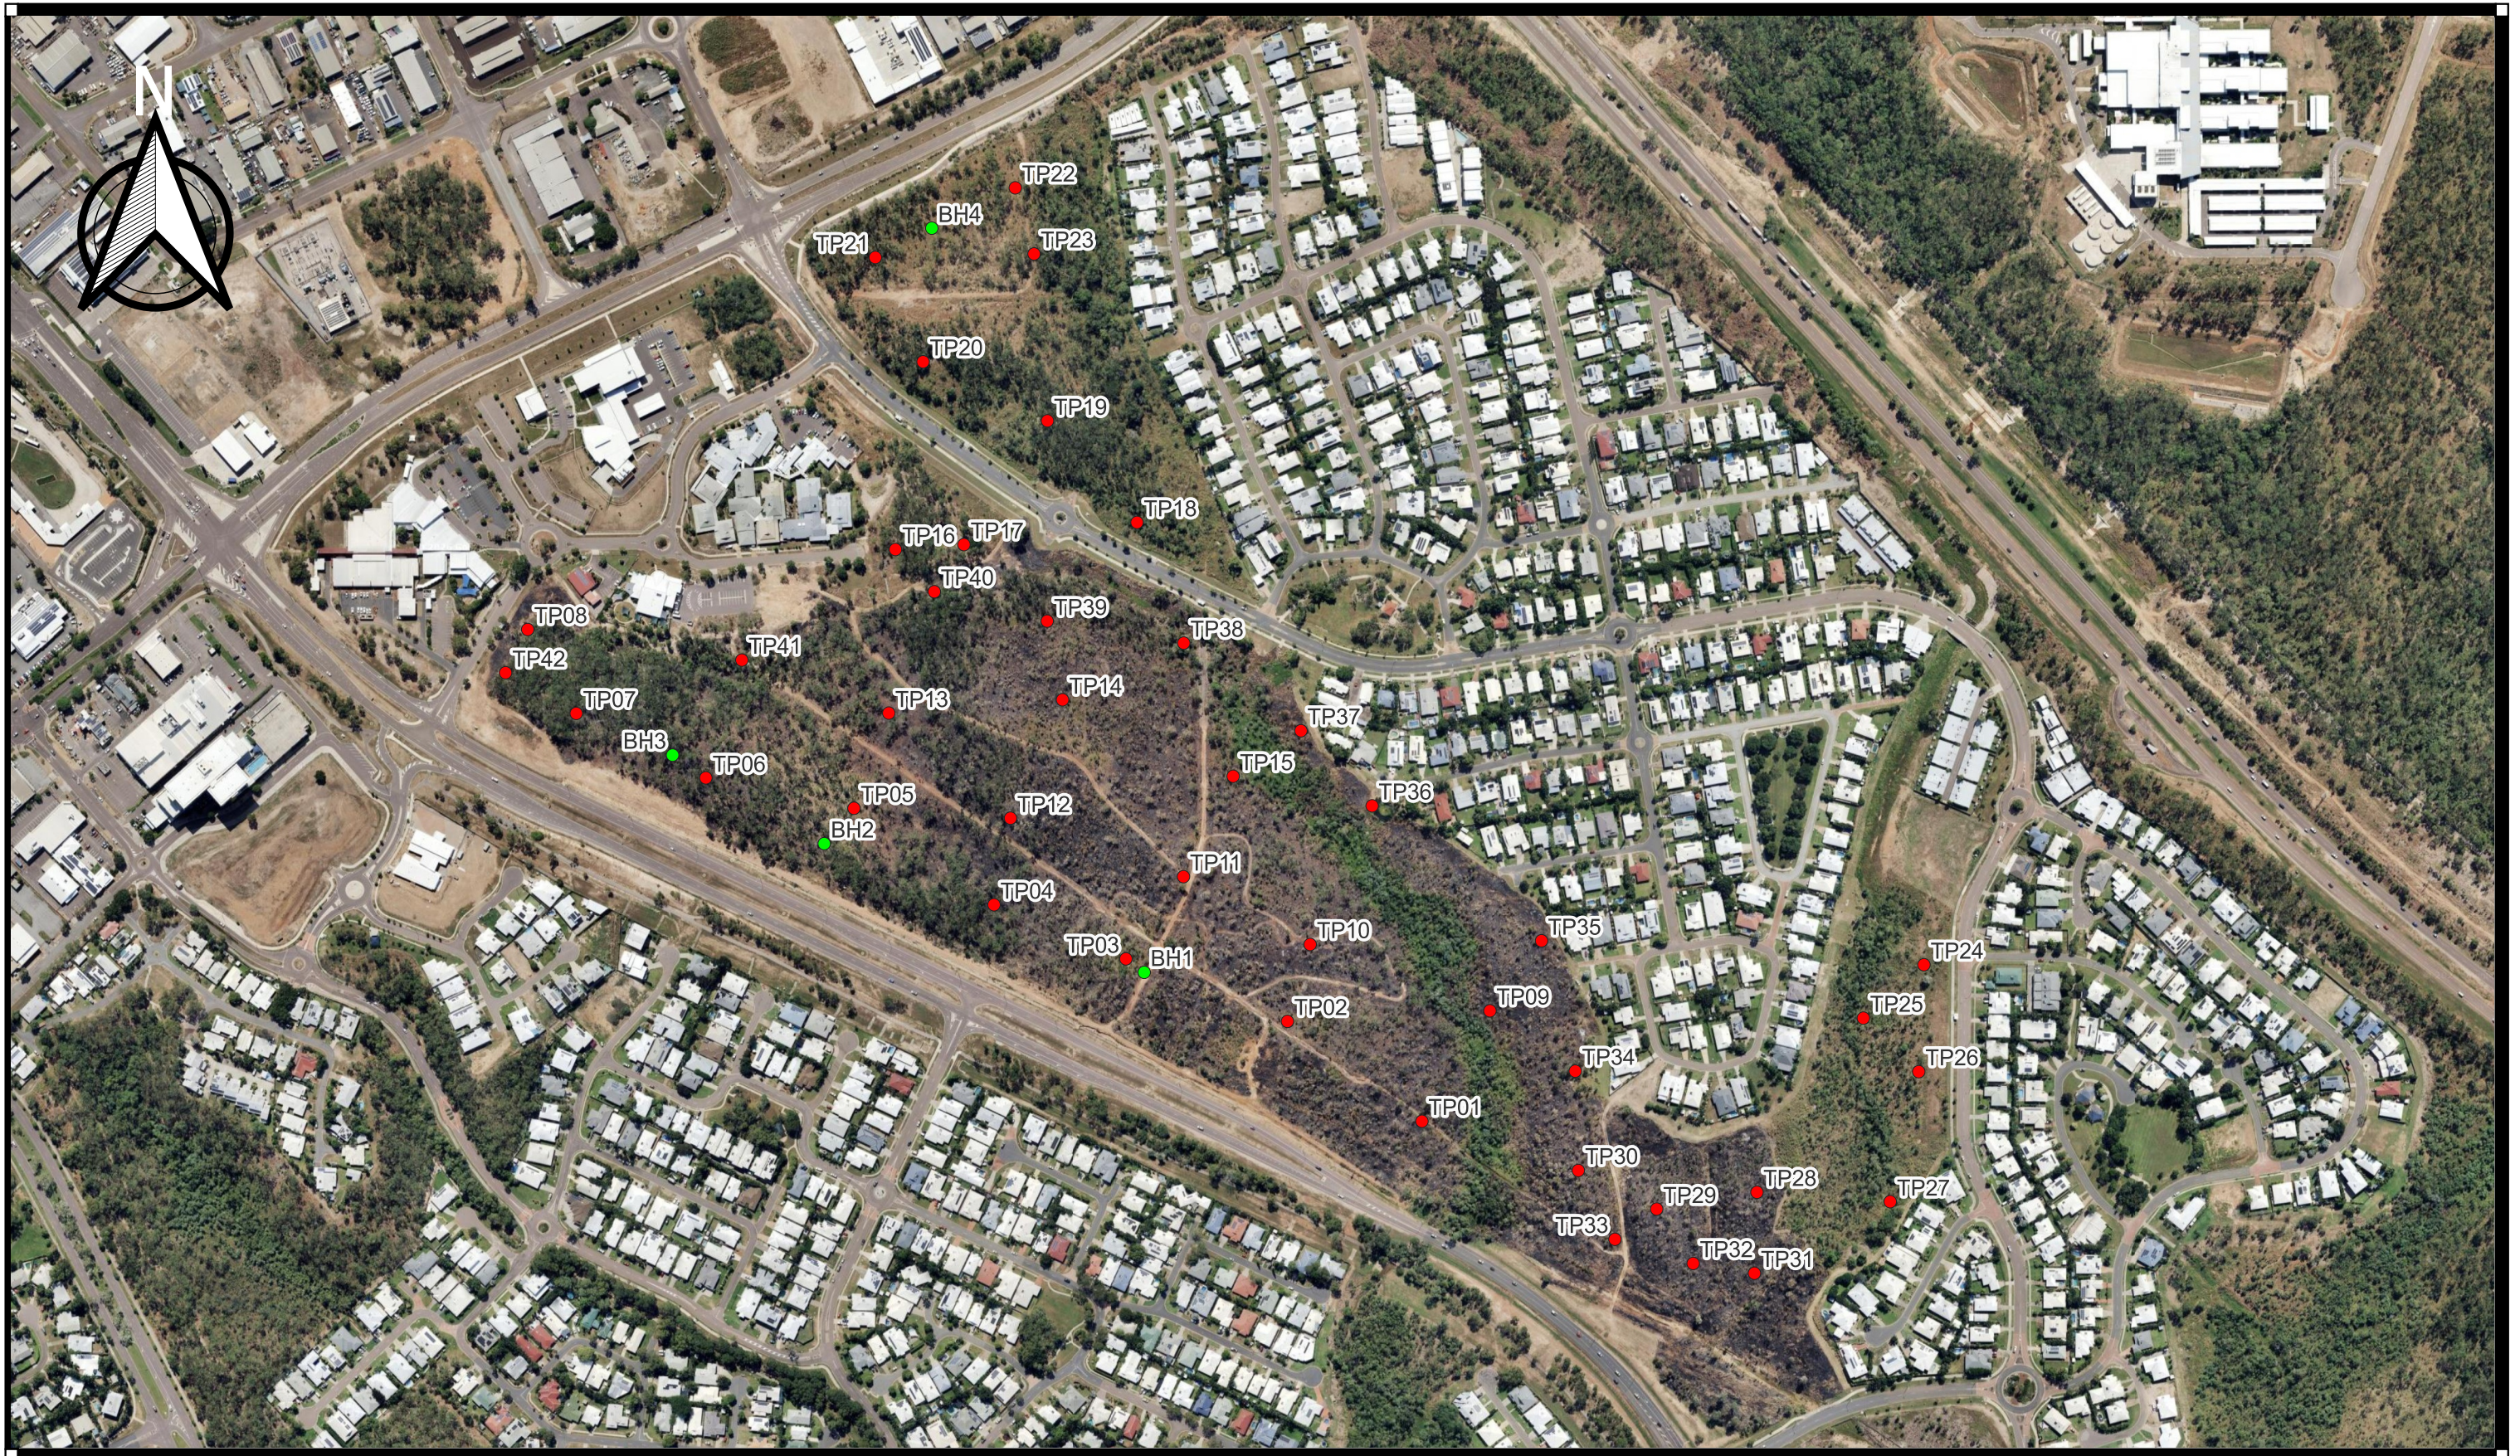
## Site Investigation Plan

- Borehole Locations
- Test pit Locations

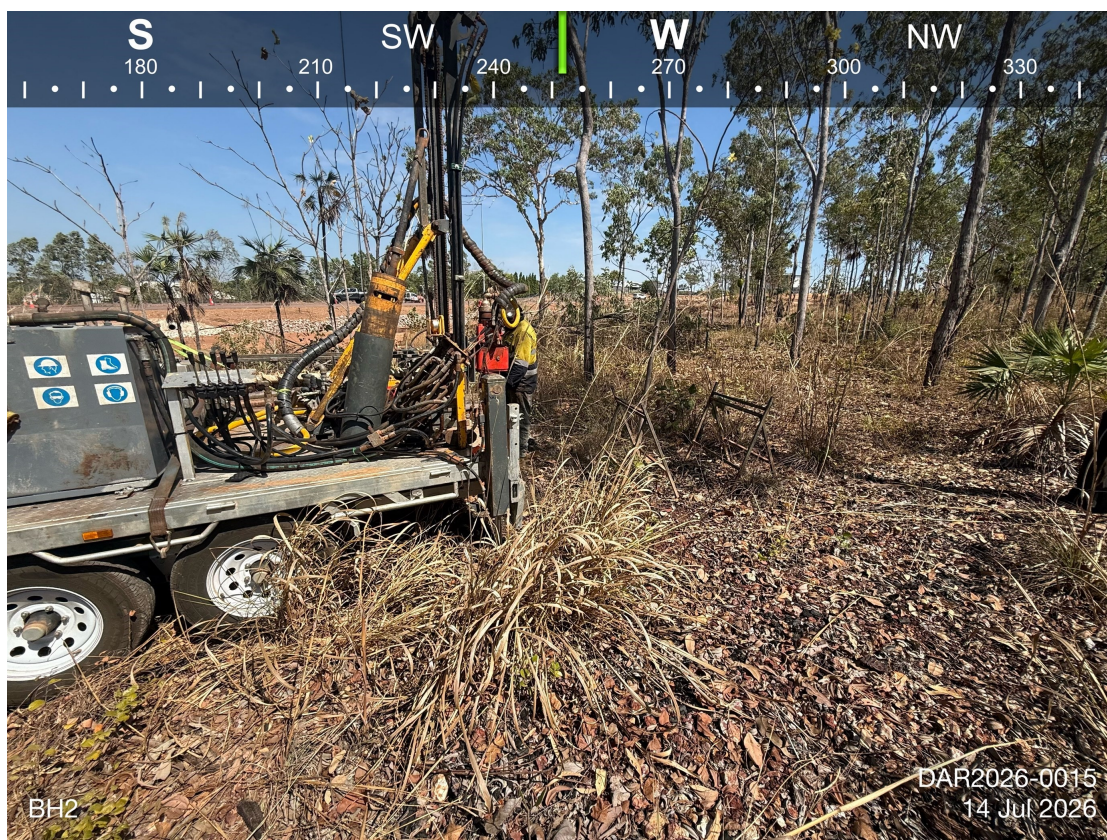
BH2\_11-57-16

# PHOTOGRAPH SHEET - BH2

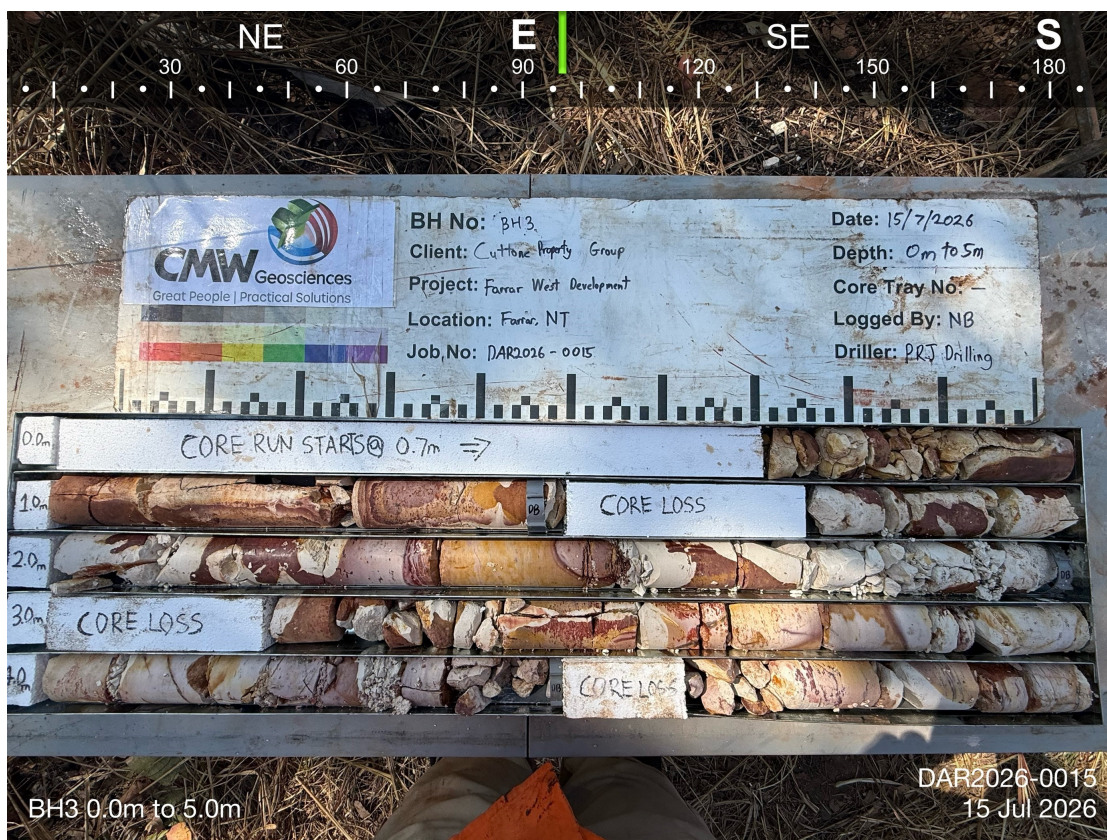
BH3 0.0m to 5.0m\_10-56-25

# PHOTOGRAPH SHEET - BH3

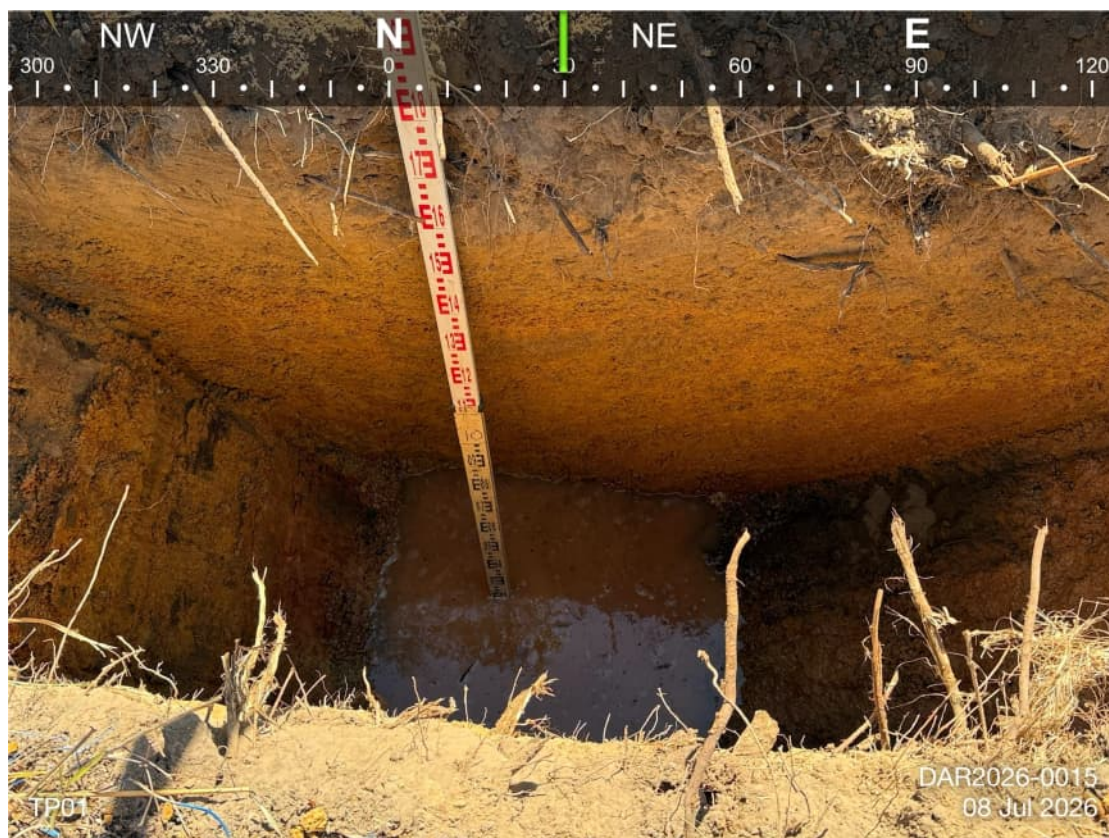
TP01\_10-51-09

| Test ID | Depth (m) | Comments |
|---|---|---|
| TP01 | 2.0 | Loose sand from 0.2 – 0.6 m, target depth reached. Groundwater at 1.8 m. |

# PHOTOGRAPH SHEET - TP01
