PRELIMINARY SITE INVESTIGATION

Little Mindil

SLR Ref: 680.30010-R01
Version No: v3.0
September 2019

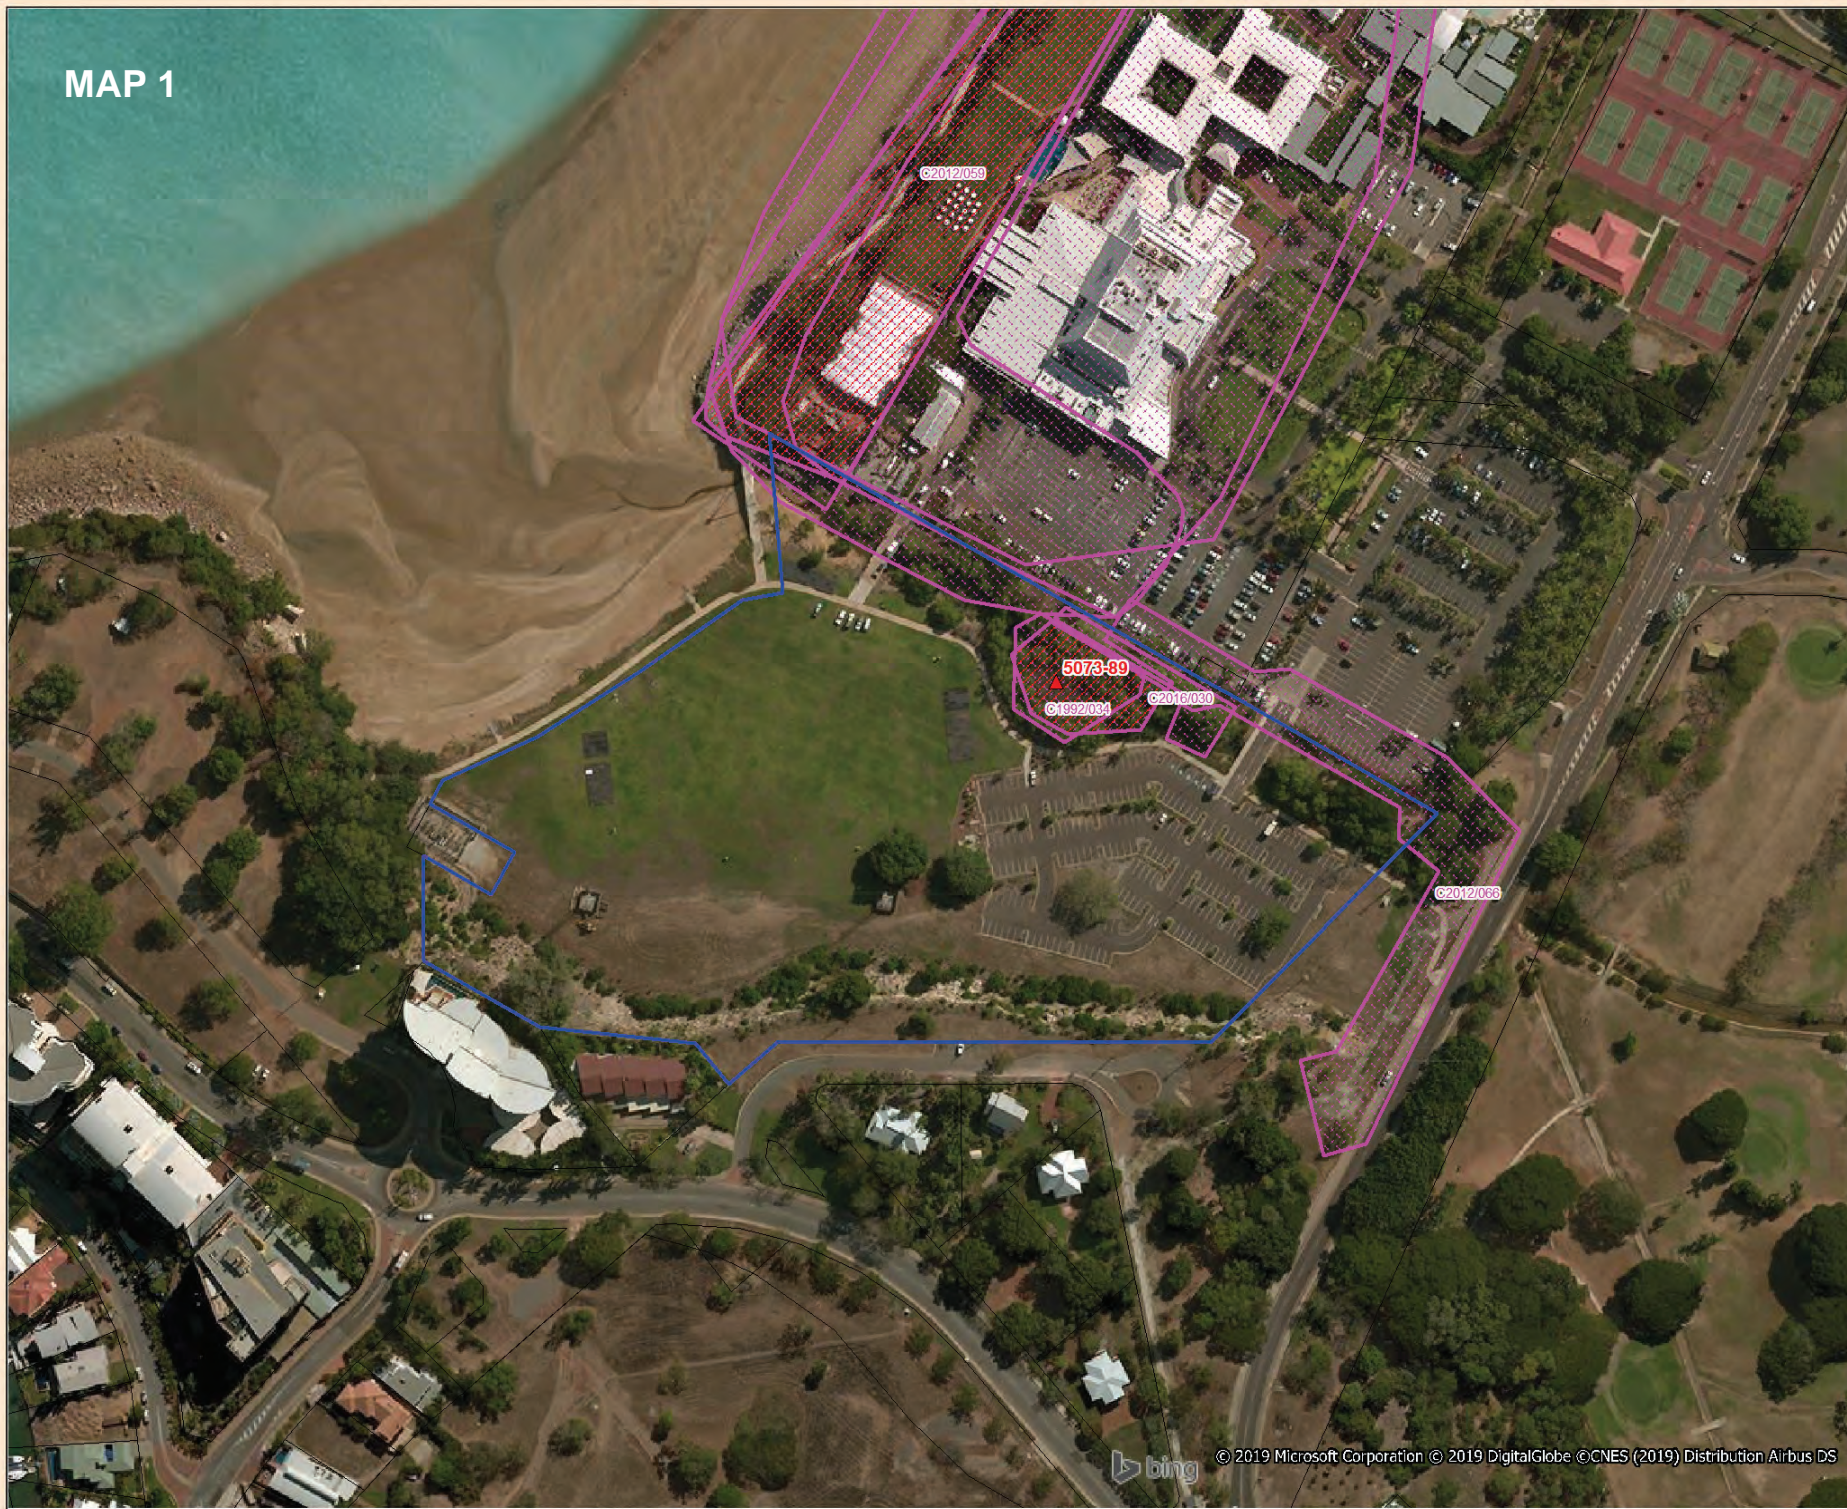
MAP 1

Registered Sacred Site 5073-89, a burial site, exists within the boundary of the Site, shown in the excerpt from the Aboriginal Areas Protection Authority (AAPA) certificate in **Figure 3**. A restricted works area is also defined along Mindil Creek and surrounding the Sacred Site.

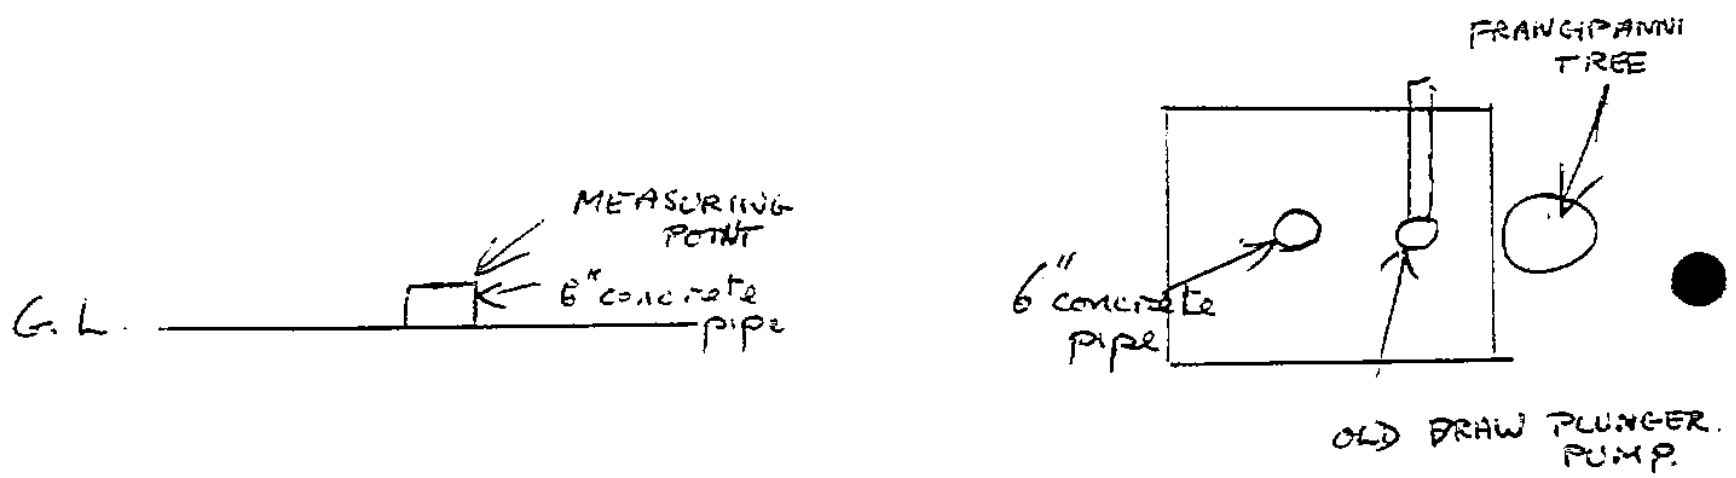
Bore Characteristic sketch

This well has a plate ~~on it~~ or block on it and is grassed over. A 6" concrete pipe is the only opening at the surface.

3. The bore is now useless and cannot be tested. No other source of water was found.
