Project 77861.01
23 May 2012
DSF:pc

Geotechnical Assessment of Proposed Site Filling and Seawalls
Stage 11 – Lots A & C
Bayview, NT

This letter report by Douglas Partners Pty Ltd (DP) provides a geotechnical assessment of proposed site filling and seawalls for Stage 11, Lots A and C at Bayview, Darwin, NT. It is understood that the assessment is required to provide additional information in respect to cross sections to ensure the land is suitably filled to a height to enable development of the lots for their intended purposes, thereby avoiding risk and damage as a result of any storm surge event. The letter report was requested by Mr Barry Young on behalf of Dover Investments Pty Ltd.

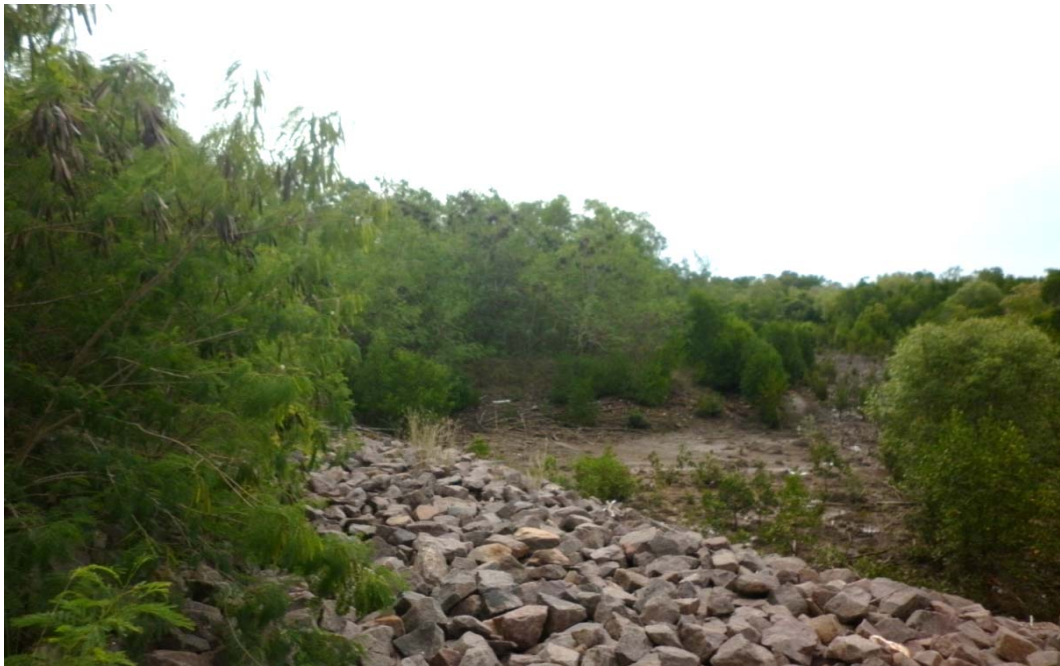
Plate 1: View of existing embankment and site surface at Lot A

The present surface conditions on Lots A and C are shown in the attached site photographs, Plates 1 and 2, taken in early May 2012. There are no mature mangroves within the lease boundary at either of the sites, and all vegetation on the earth and rockfill slopes is regrowth since the slopes were constructed.

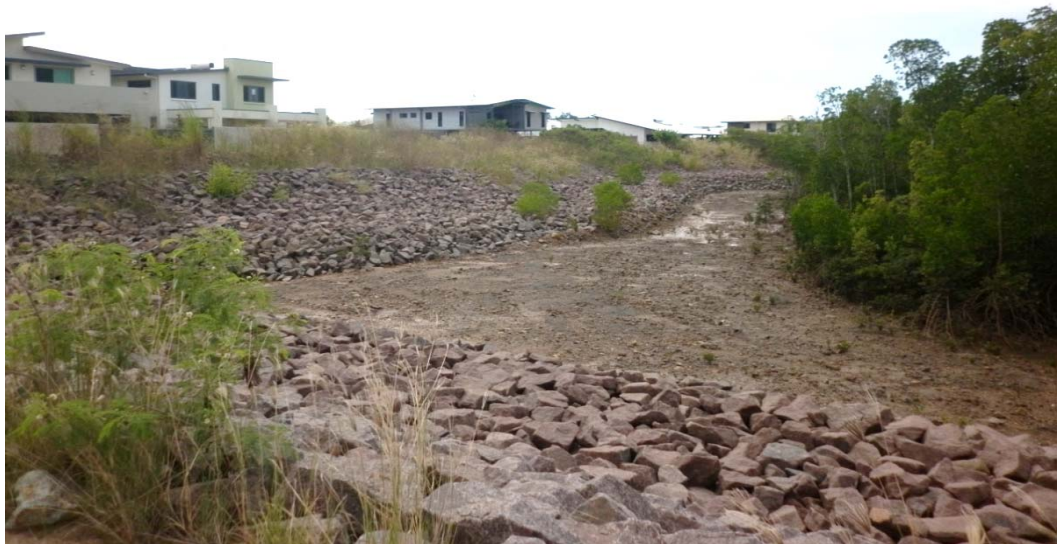
Plate 2: View of existing embankment and site surface at Lot C

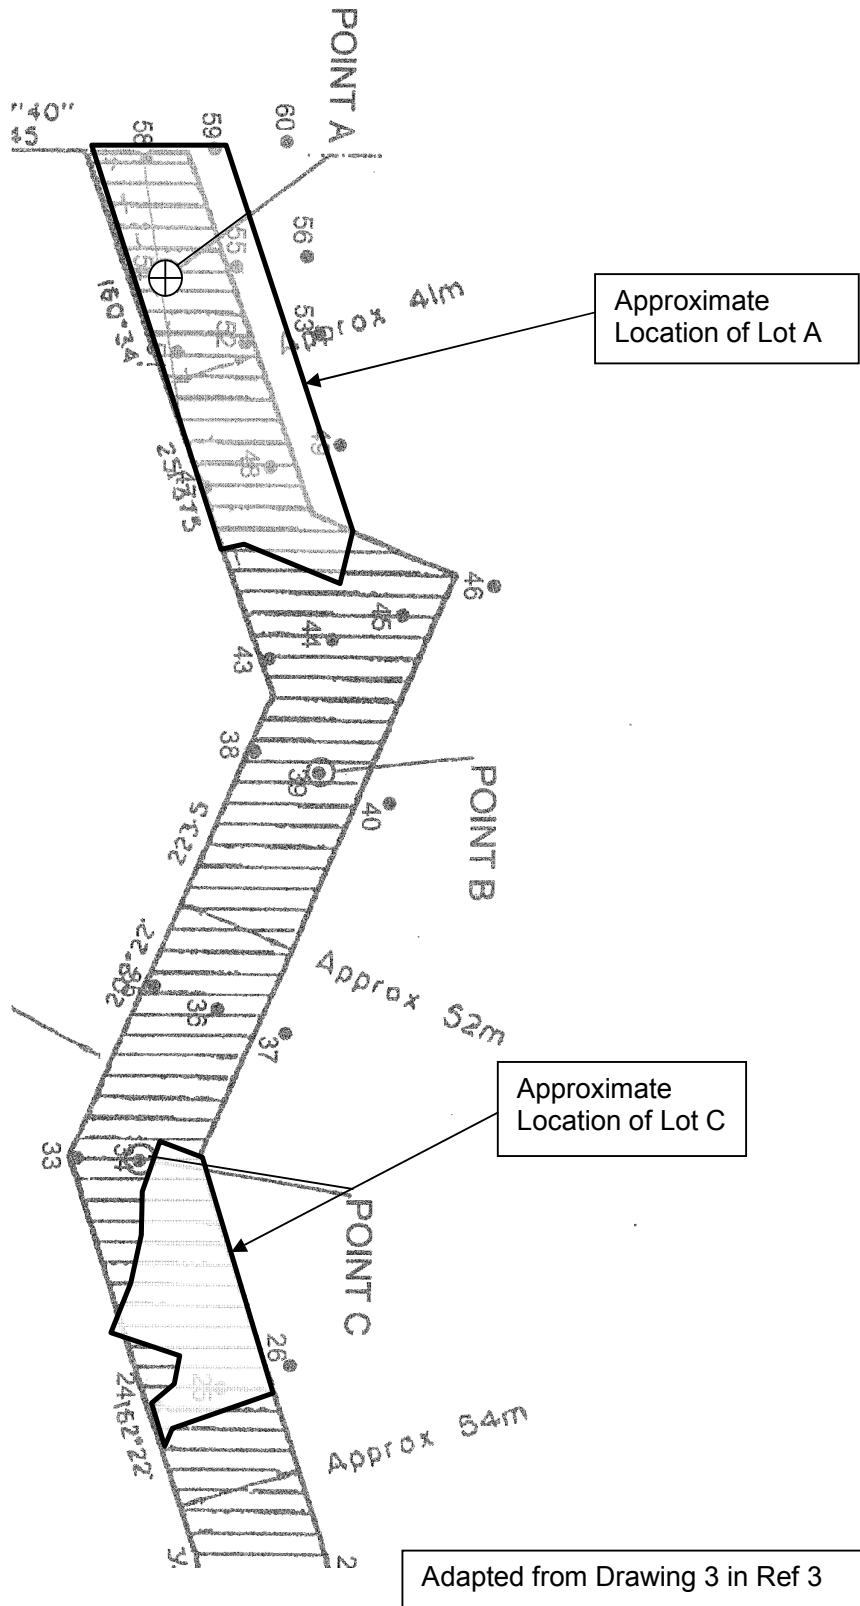
TITLE: Mud Probe Locations and
Surcharge Calculation Points
Stage 11 - Lots A and C
Bayview, NT.

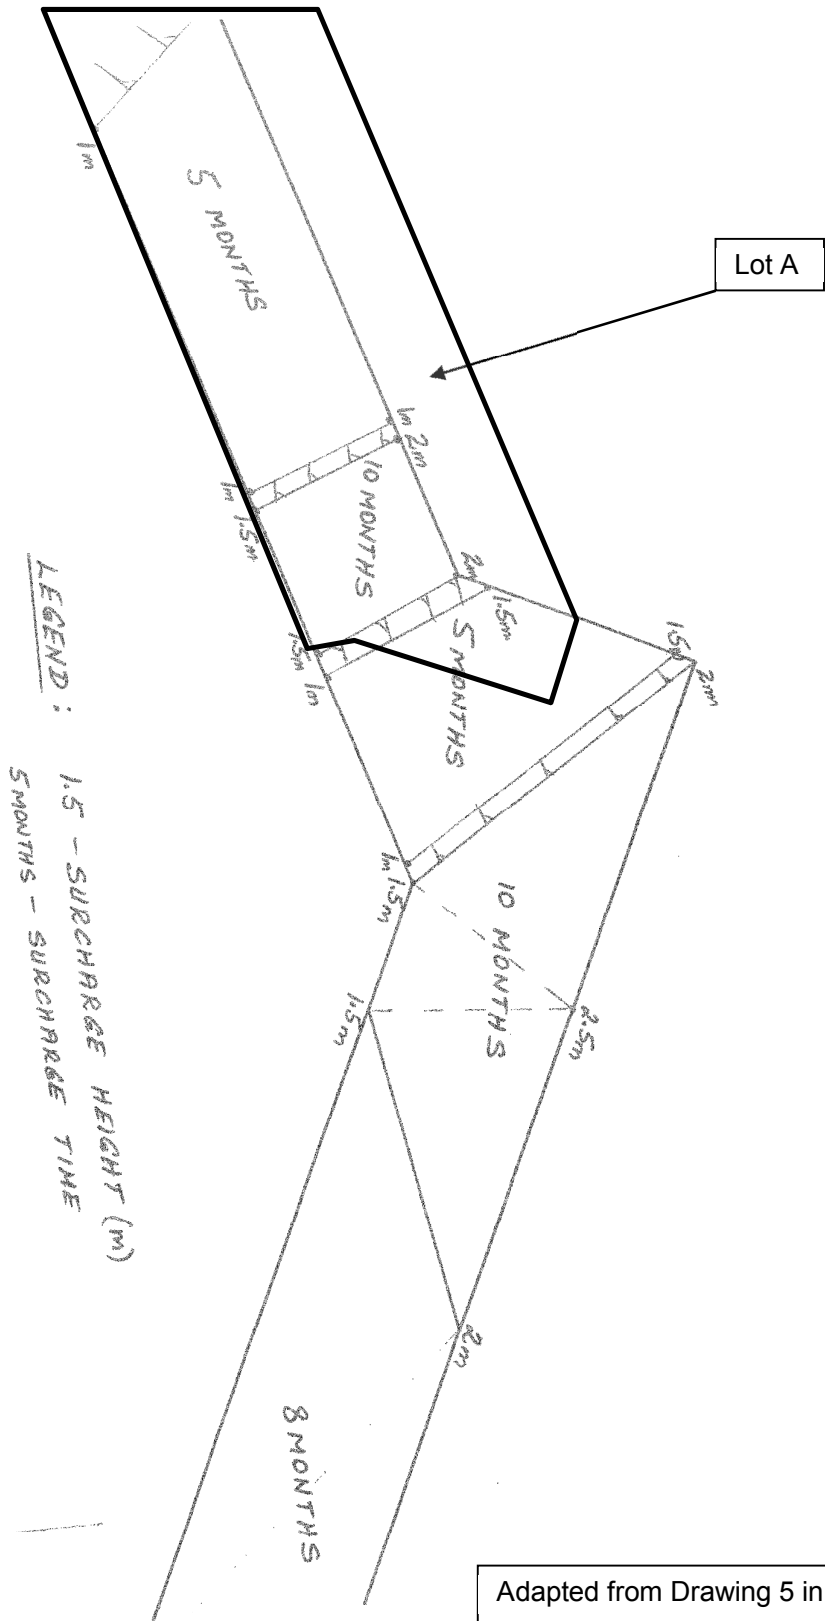
TITLE: Typical Surcharge Heights and Surcharge Times
 Proposed Lot A
 Stage 11, Bayview, NT.

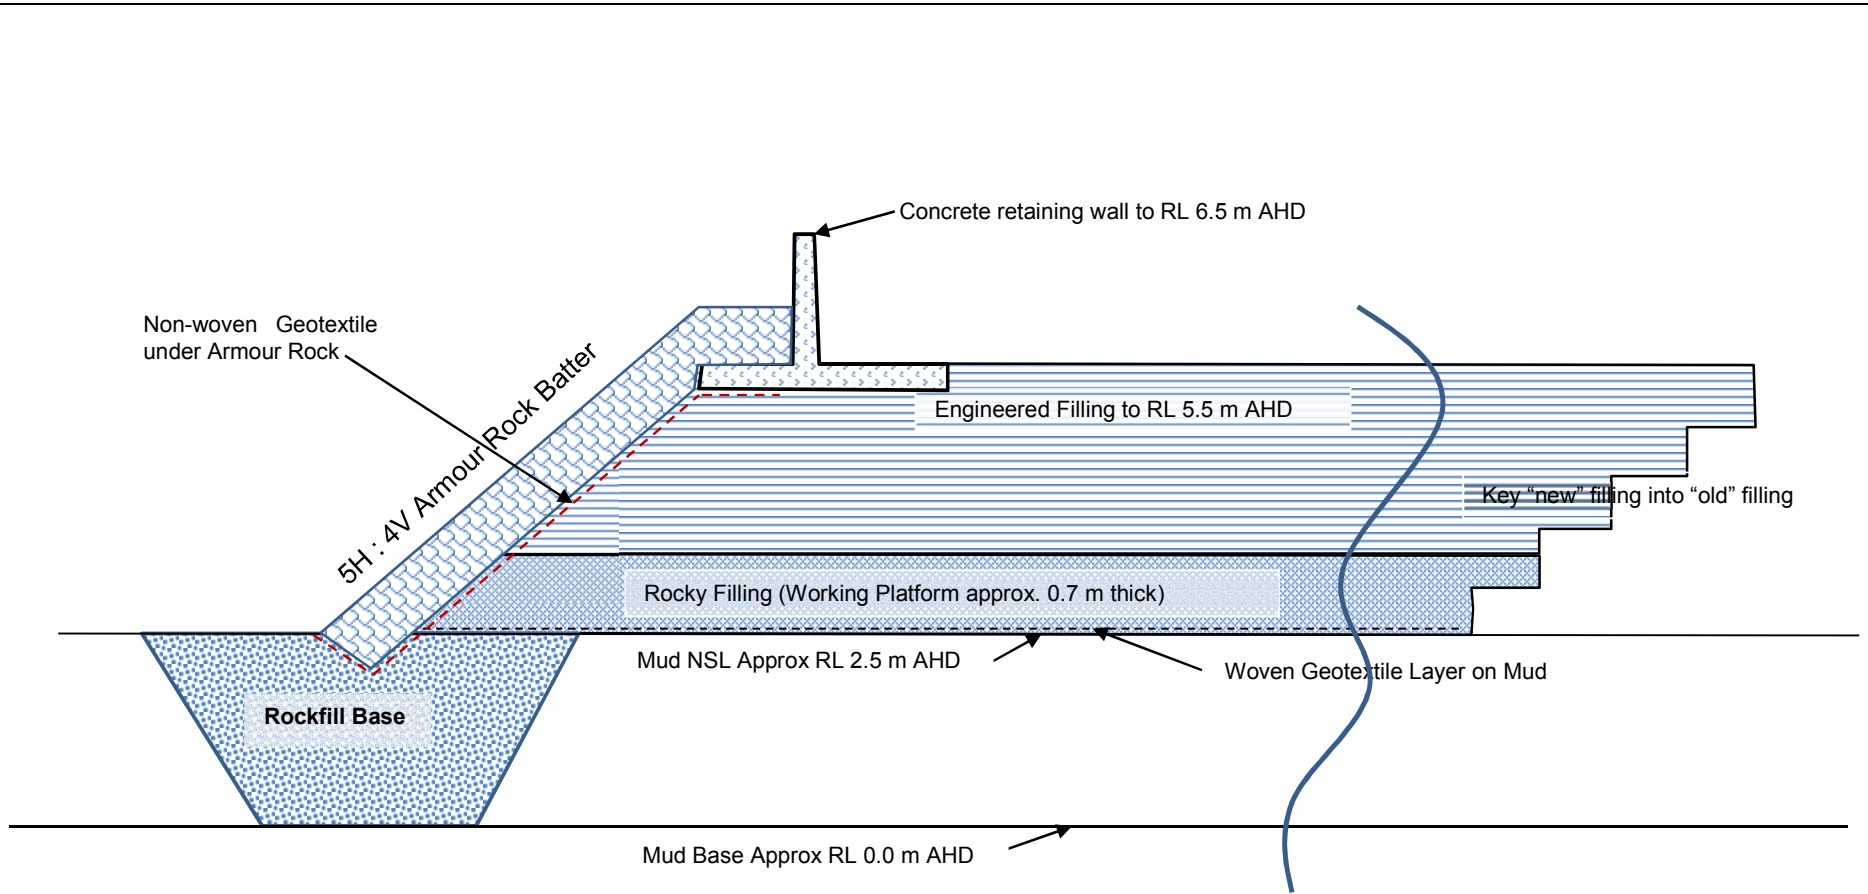
TITLE: Typical Section through Final Seawall
 Proposed Stage 11 - Lots A and C
 Bayview, NT.

The proposed composite wall profile with a rockfill base will be stable, will enable development of the lots for their intended purposes, and with a crest level of RL6.5 m AHD will mitigate risk and damage as a result of any storm surge event.
